Manhole Inspection Summary

Manhole # S43QQ_017MH

Insp Date: **4/2/07 2:01 PM**

Location Address: **2541 AISQUITH ST**

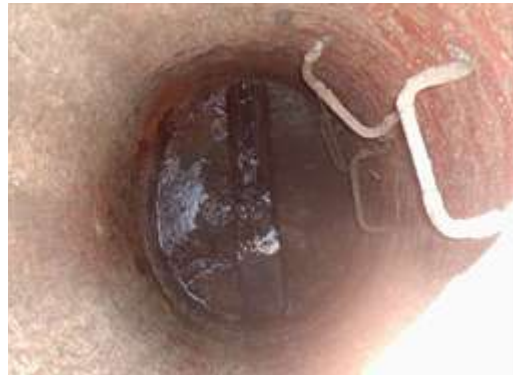
Top View

Corroded steps. Evidence of surcharge - Bench debris. Channel debris.

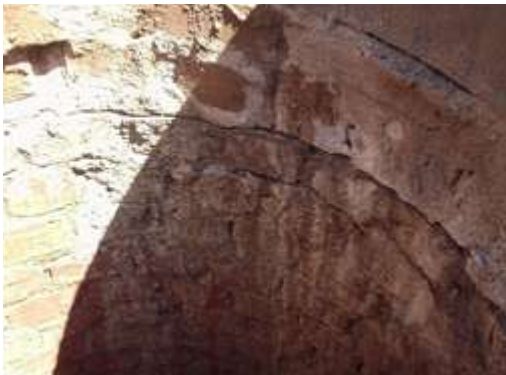
Defect

Frame leaks. Adjustment and Corbel deterioration and infiltration.

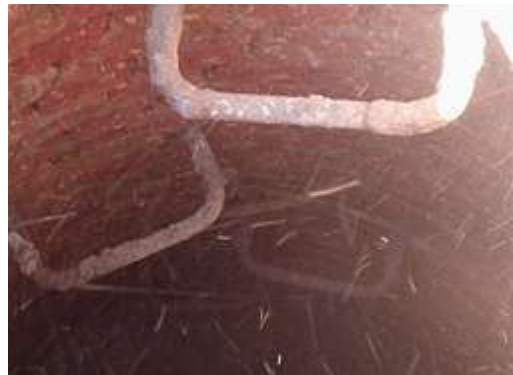
Defect

Corbel deterioration and infiltration.

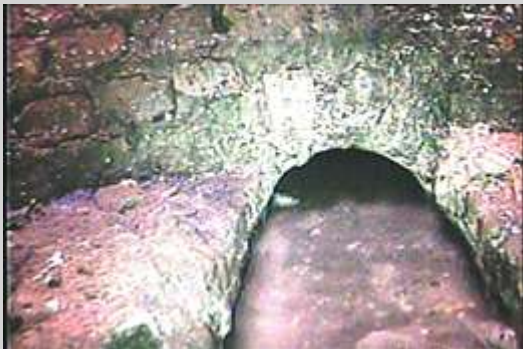
8 in. Circular Gravity Sewer Pipe In @ 6 O'Clock

Barrel deterioration and infiltration.
